DOT/FAA/RD-91/1

**Composite Profiles of  
Helicopter Mishaps at  
Heliports and Airports**

January 1992

Final Report

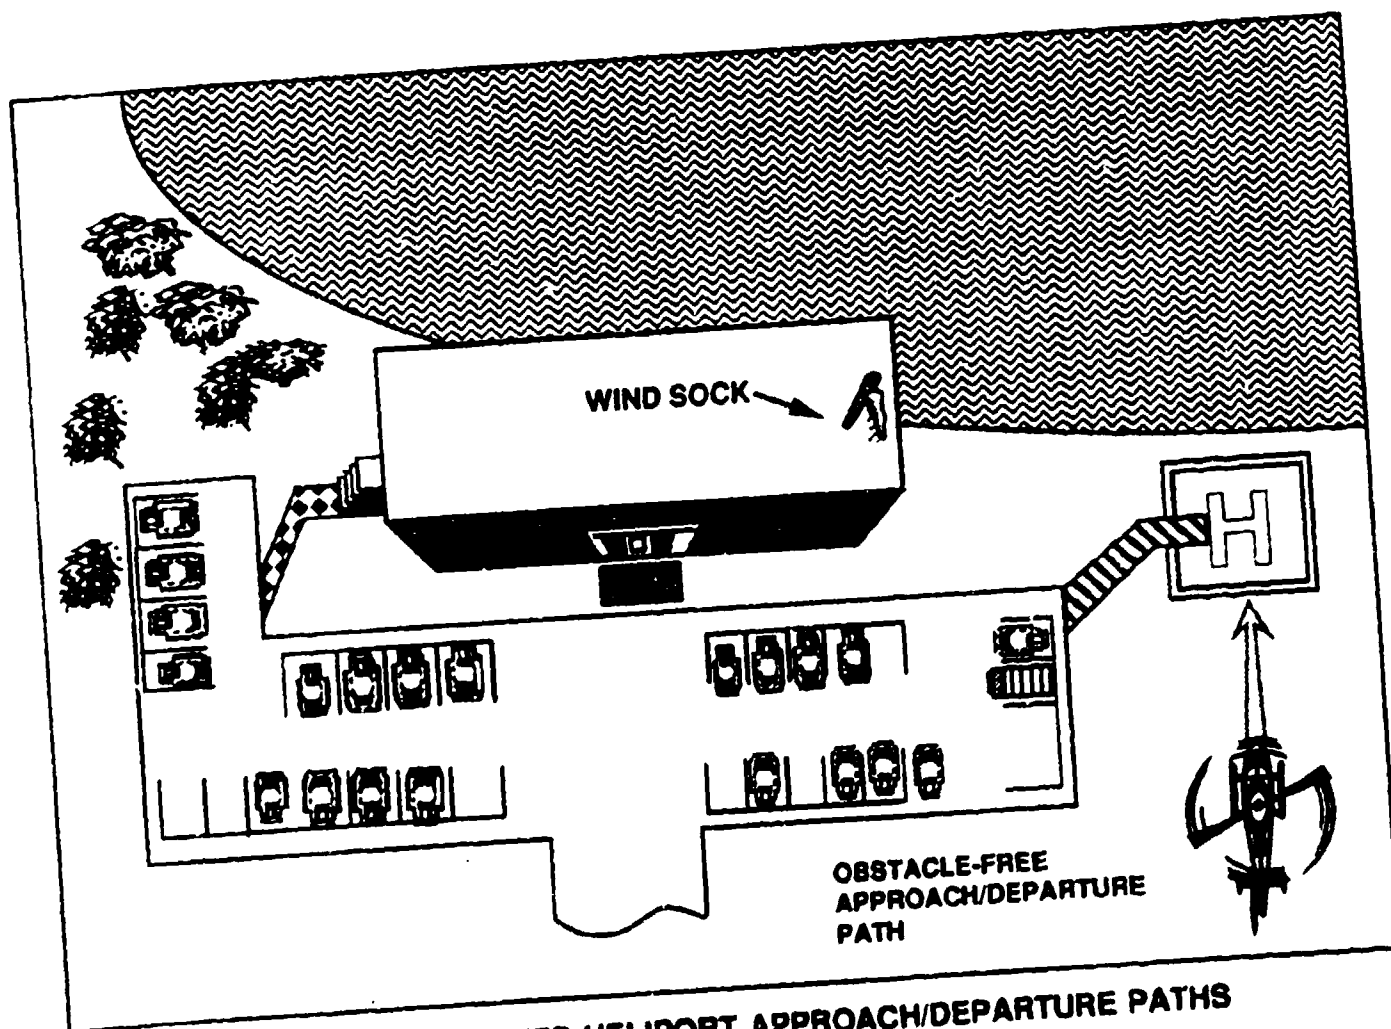
FIGURE 5 IMPROVED HELIPORT APPROACH/DEPARTURE PATHS

Approach/Departure Paths - Pilots should attempt to adhere to the recommended approach/departure path whenever conditions allow for such procedures. At times, it may seem easy to put aside established procedures when there appears to be plenty of clear space surrounding a heliport. When the wind is not a significant factor, a pilot may choose to approach a heliport from a direction other than that prescribed by the heliport markings. However, judicious approach/departure paths are designed based on several factors, not just prevailing wind. Helicopter performance, safety, noise, obstacles, and objects underlying the approach/departure paths must be considered. Whenever possible, avoid flying over people, vehicles, and structures, particularly during takeoffs and landings. Figure 5 depicts the proper approach.

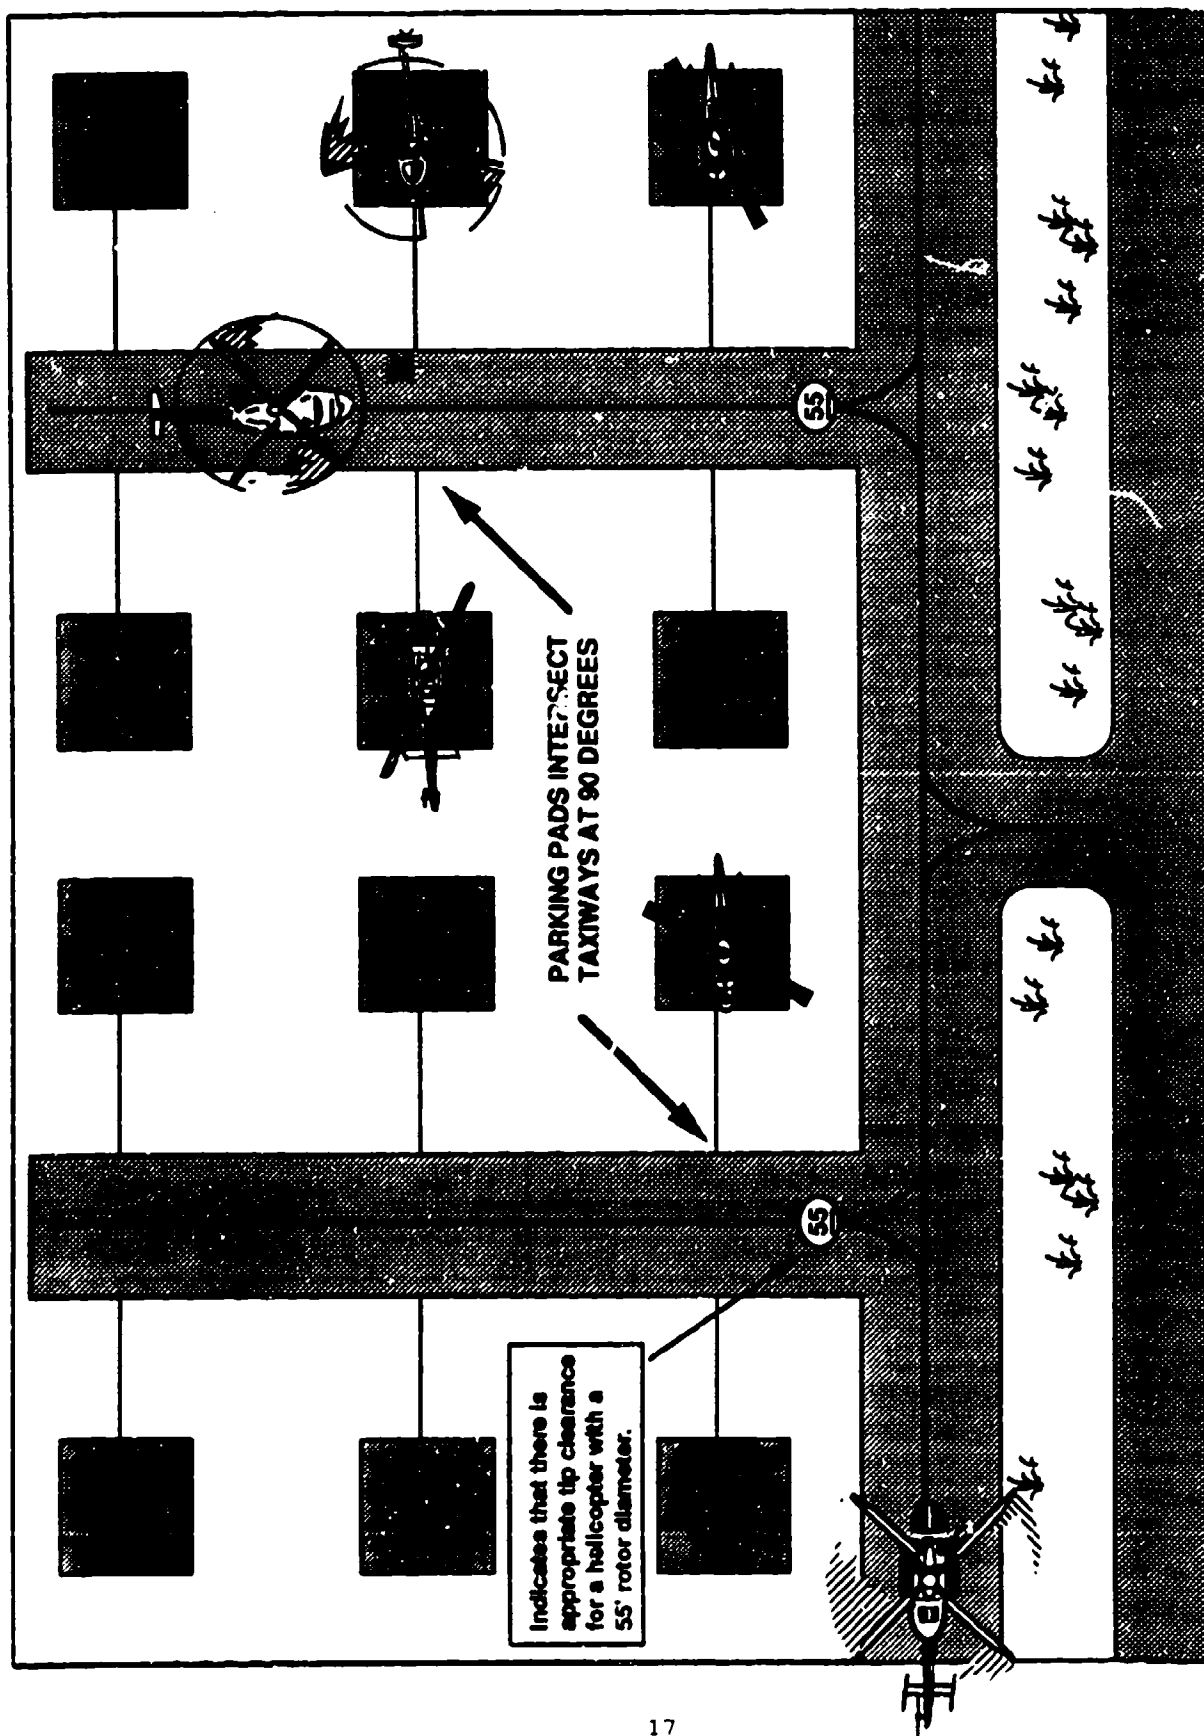
FIGURE 7 IMPROVED HELIPAD AND TAXI LANE ALIGNMENT

However, in this particular instance the design of the parking area necessitated that the pilot be able to see more than 90 degrees to his right.

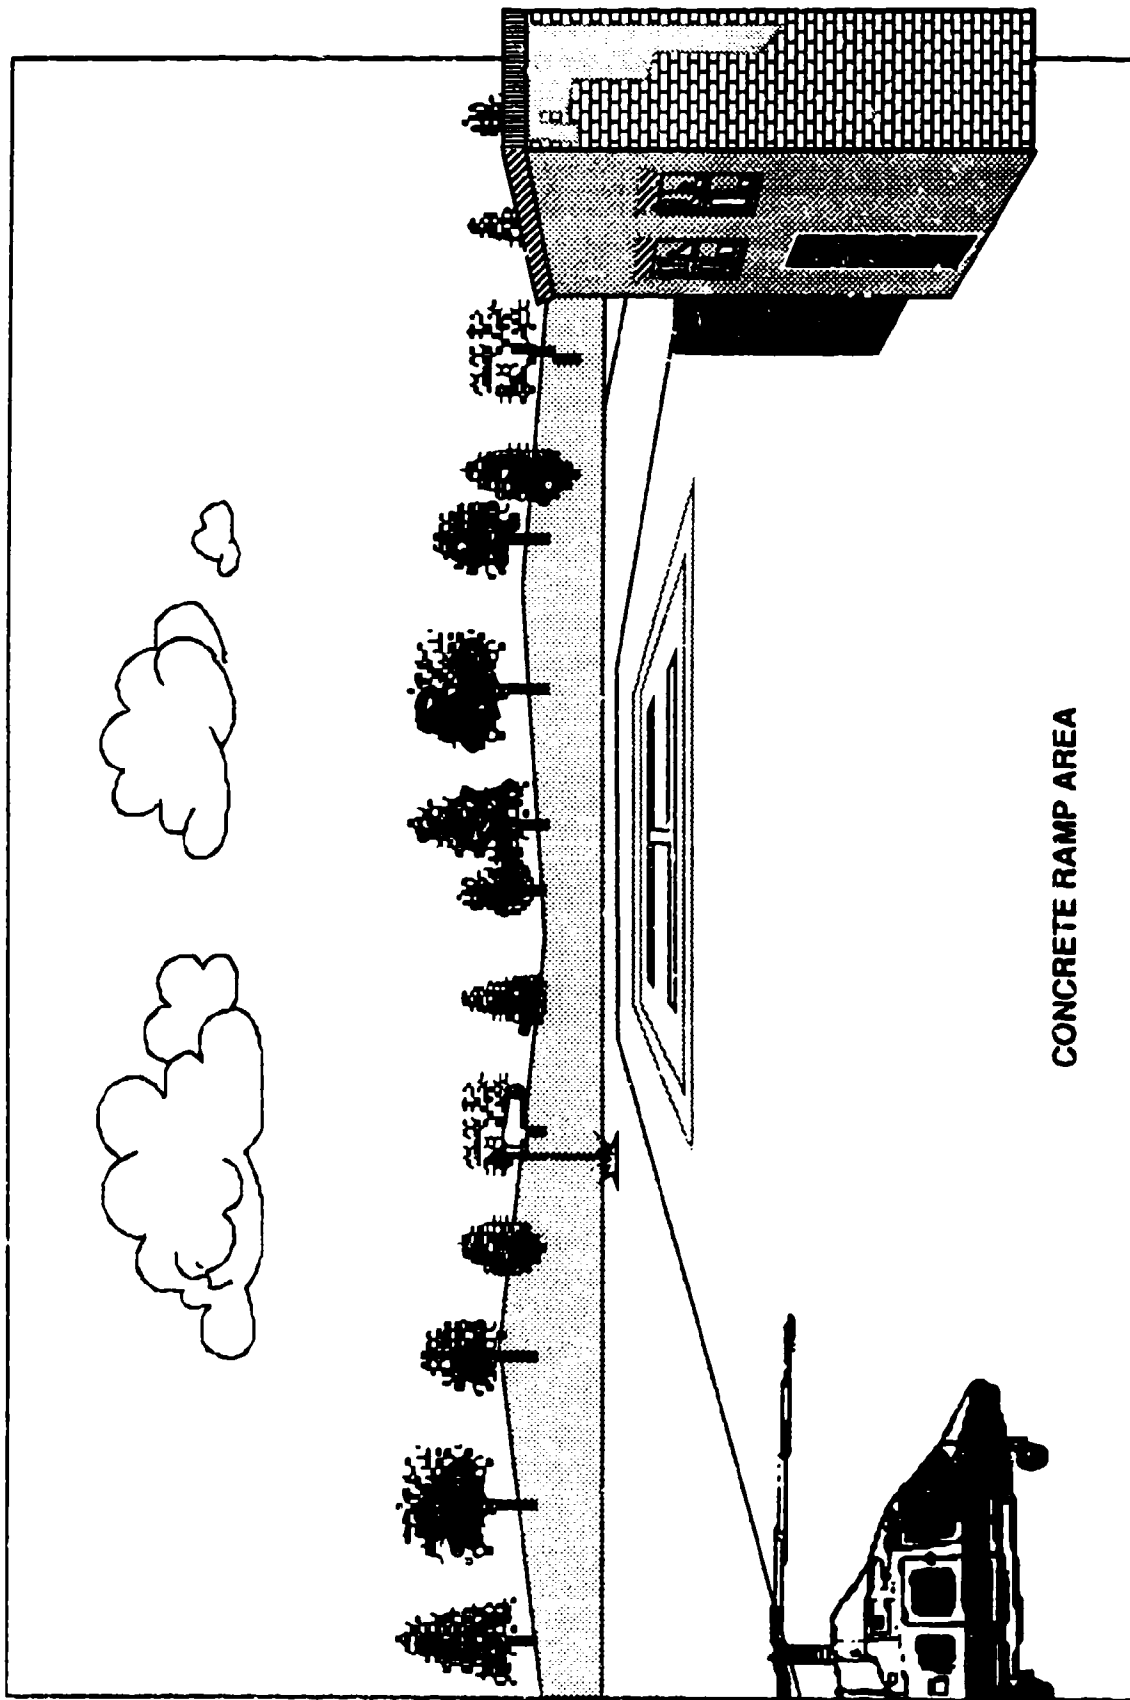
FIGURE 9 IMPROVED HELIPORT SURFACE COMPOSITION

Surface Material - It is important that operational areas be capable of supporting the full weight of the aircraft. These areas include FATOs, refueling areas, and parking pads. Concrete is preferable to asphalt. This is particularly true for locations that experience high daytime temperatures during the year. Figure 9 depicts the heliport with design improvements that enhance safety.

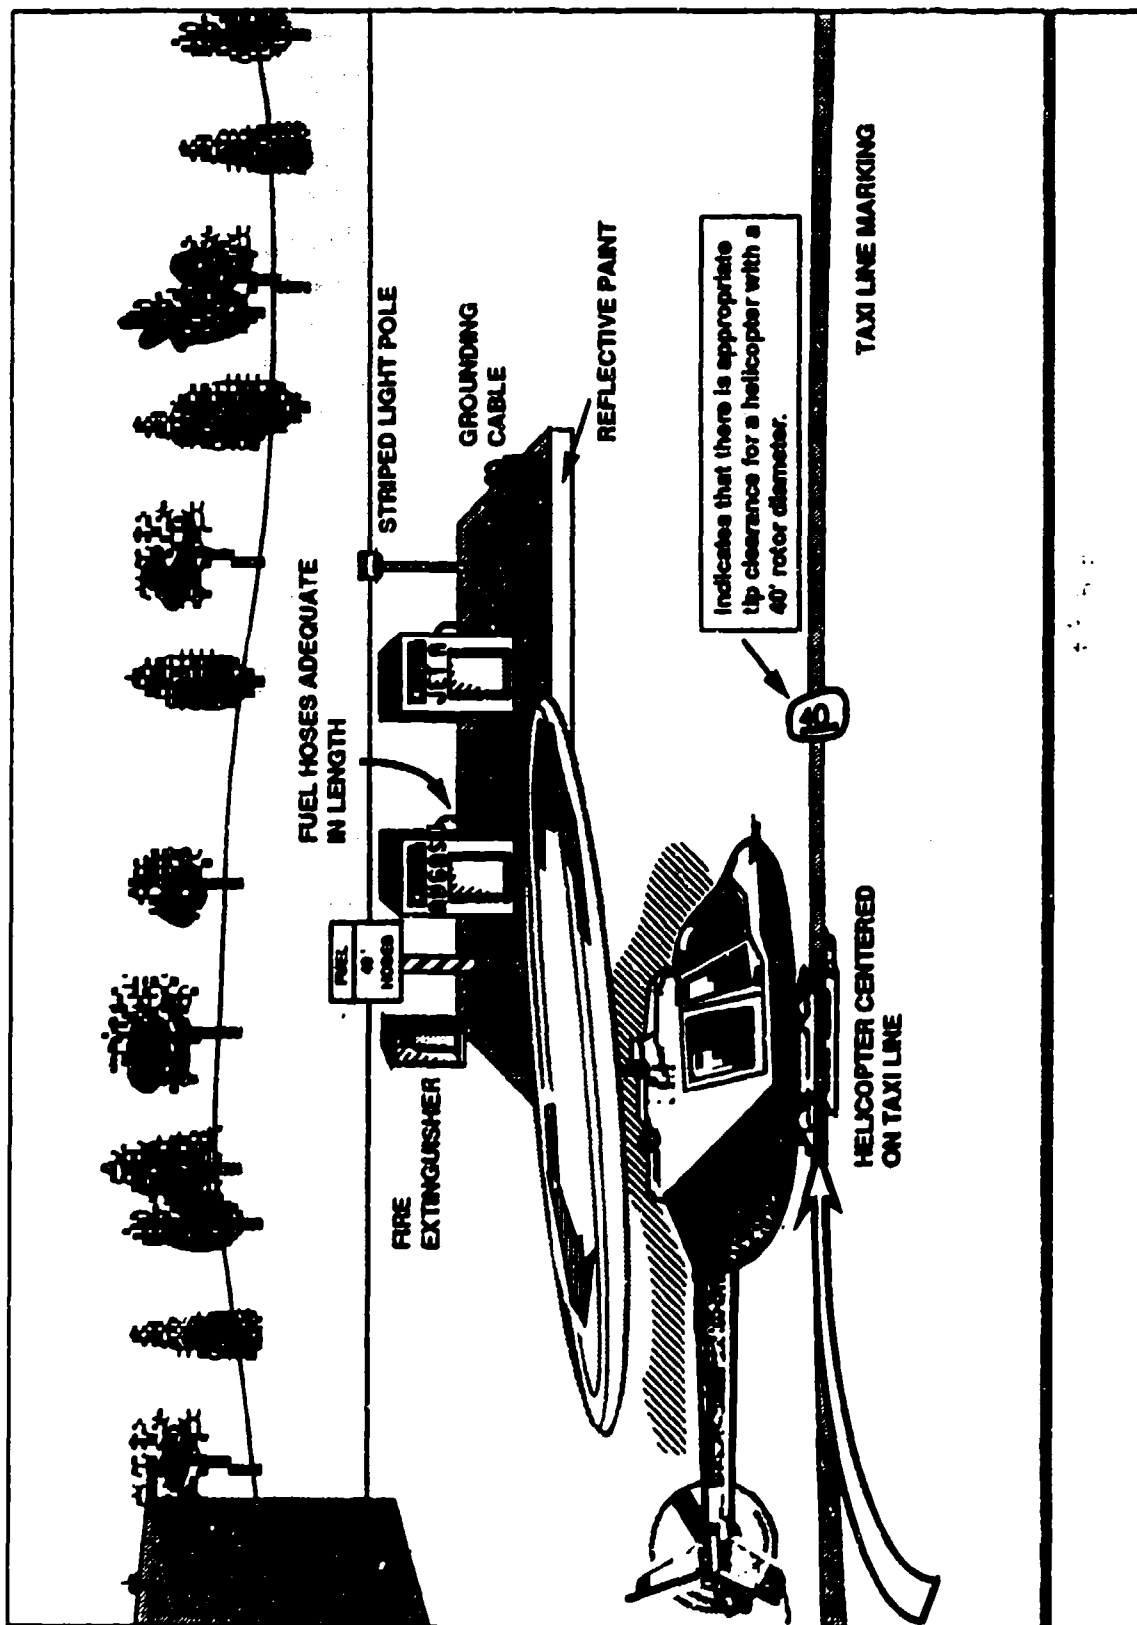
FIGURE 11 IMPROVED HELIPORT DESIGN - TAXI LINE MARKING

Ground Markings - At refueling areas that include service for helicopters, taxi lines must clearly provide adequate clearance for safe operations. That is, if large helicopters may not operate safely in these areas, it should be clearly indicated as such. One method may be to post the largest rotor diameter accommodated on the taxi line. If taxi lines are meant as a guide to fixed-wing aircraft only and are not meant for helicopters, then it should be noted as such. Figure 11 depicts the heliport with design improvements that enhance safety.

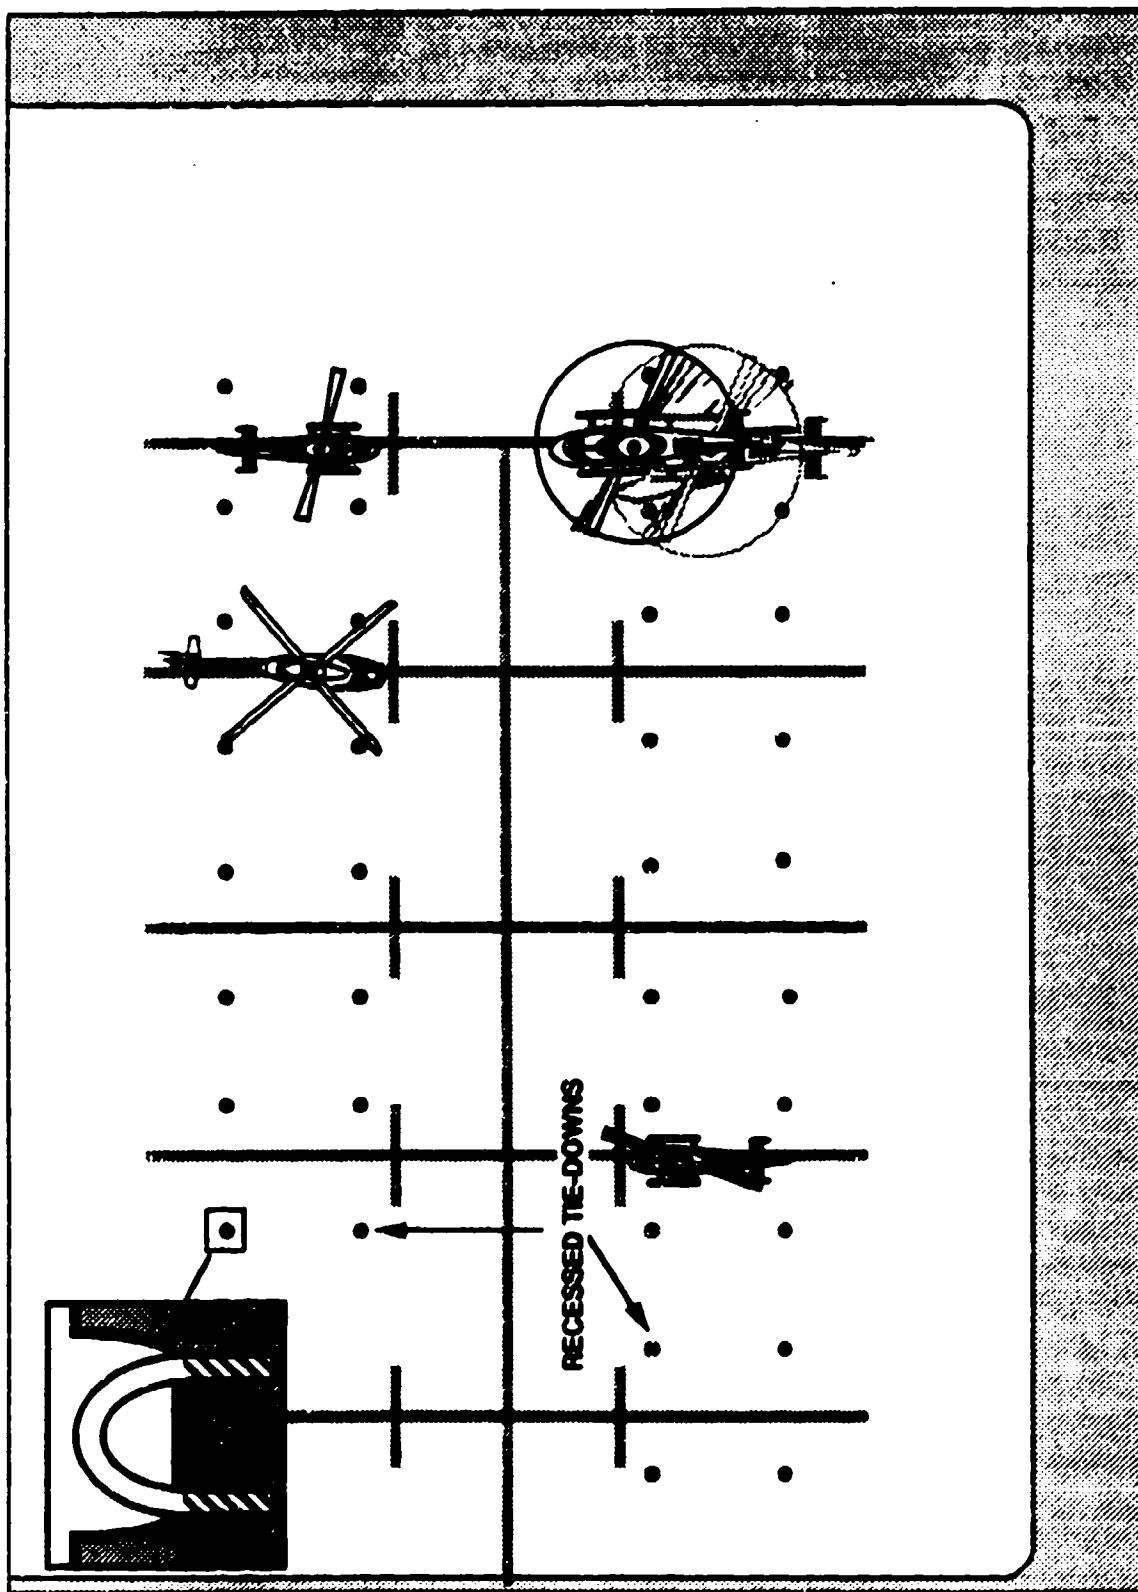
FIGURE 13 IMPROVED HELIPORT DESIGN - TIE-DOWN ANCHOR

Flat Operating Surface - Helicopters require flat operating surfaces. Mishap data shows that just about any object protruding above the operating surface has the potential for causing a mishap. Helicopters have caught landing gear on objects such as grounding eyes, bolts, drainage grates, perimeter lights, and helipad lips. Although an object may not appear to be a hazard, it is important to recognize that any object that protrudes above the operating surface represents a potential cause for a mishap. This design consideration is important even when the helicopters using the facility are equipped with wheeled landing gear. Figure 13 depicts the heliport with design improvements that enhance safety.

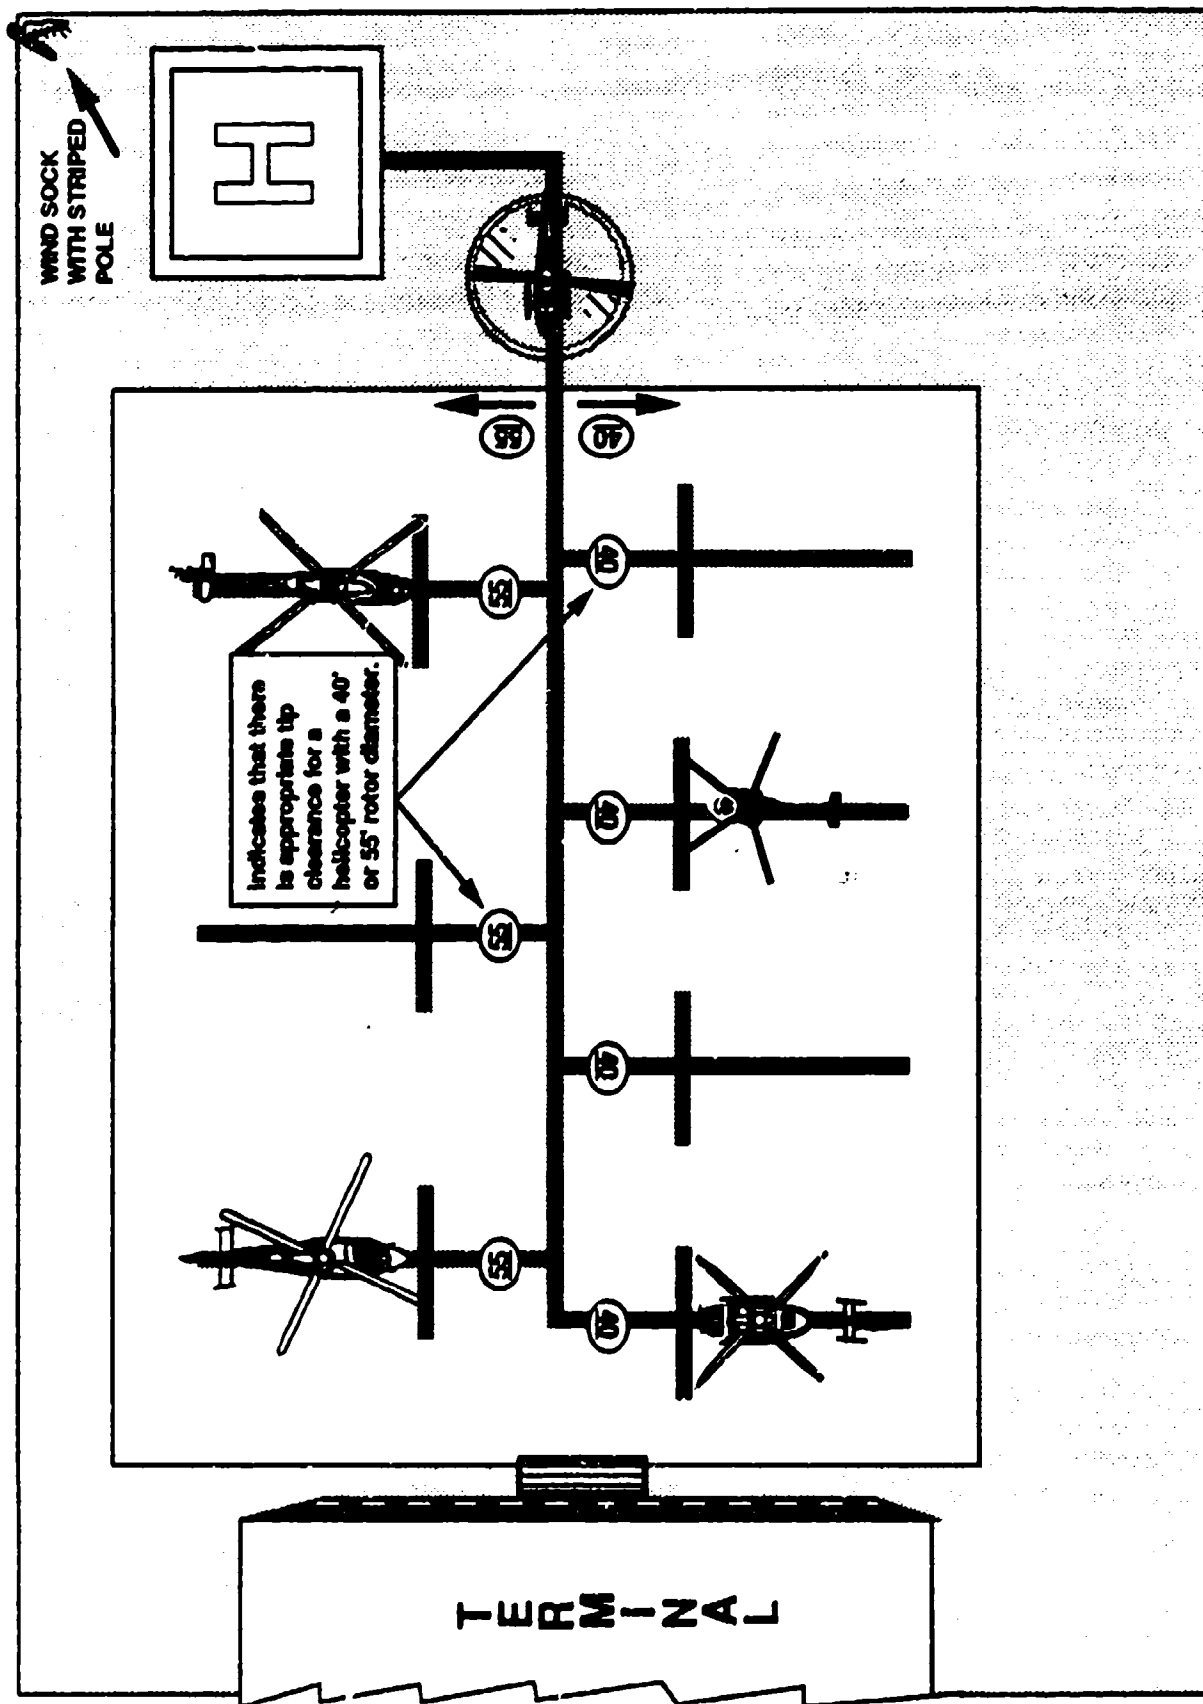
FIGURE 17 IMPROVED HELIPORT DESIGN - ADEQUATE PARKING AREA SIZE

Communications - Even when radio communications are used, UNICOM operators are not certificated as air traffic controllers, and their information is considered advisory in nature. However, the rather casual suggestion of "spot 3 or 4" and the lack of more specific phraseology by both the helicopter crews and the UNICOM operator may have contributed to the use of non-standard parking procedures. Fixed based operators (FBO's) should consider providing basic parking information to the pilot such as the parking space designator and what diameter rotor system can be accommodated in that spot. This information should be adjacent to the parking space and painted so that it can be clearly seen under all light conditions.

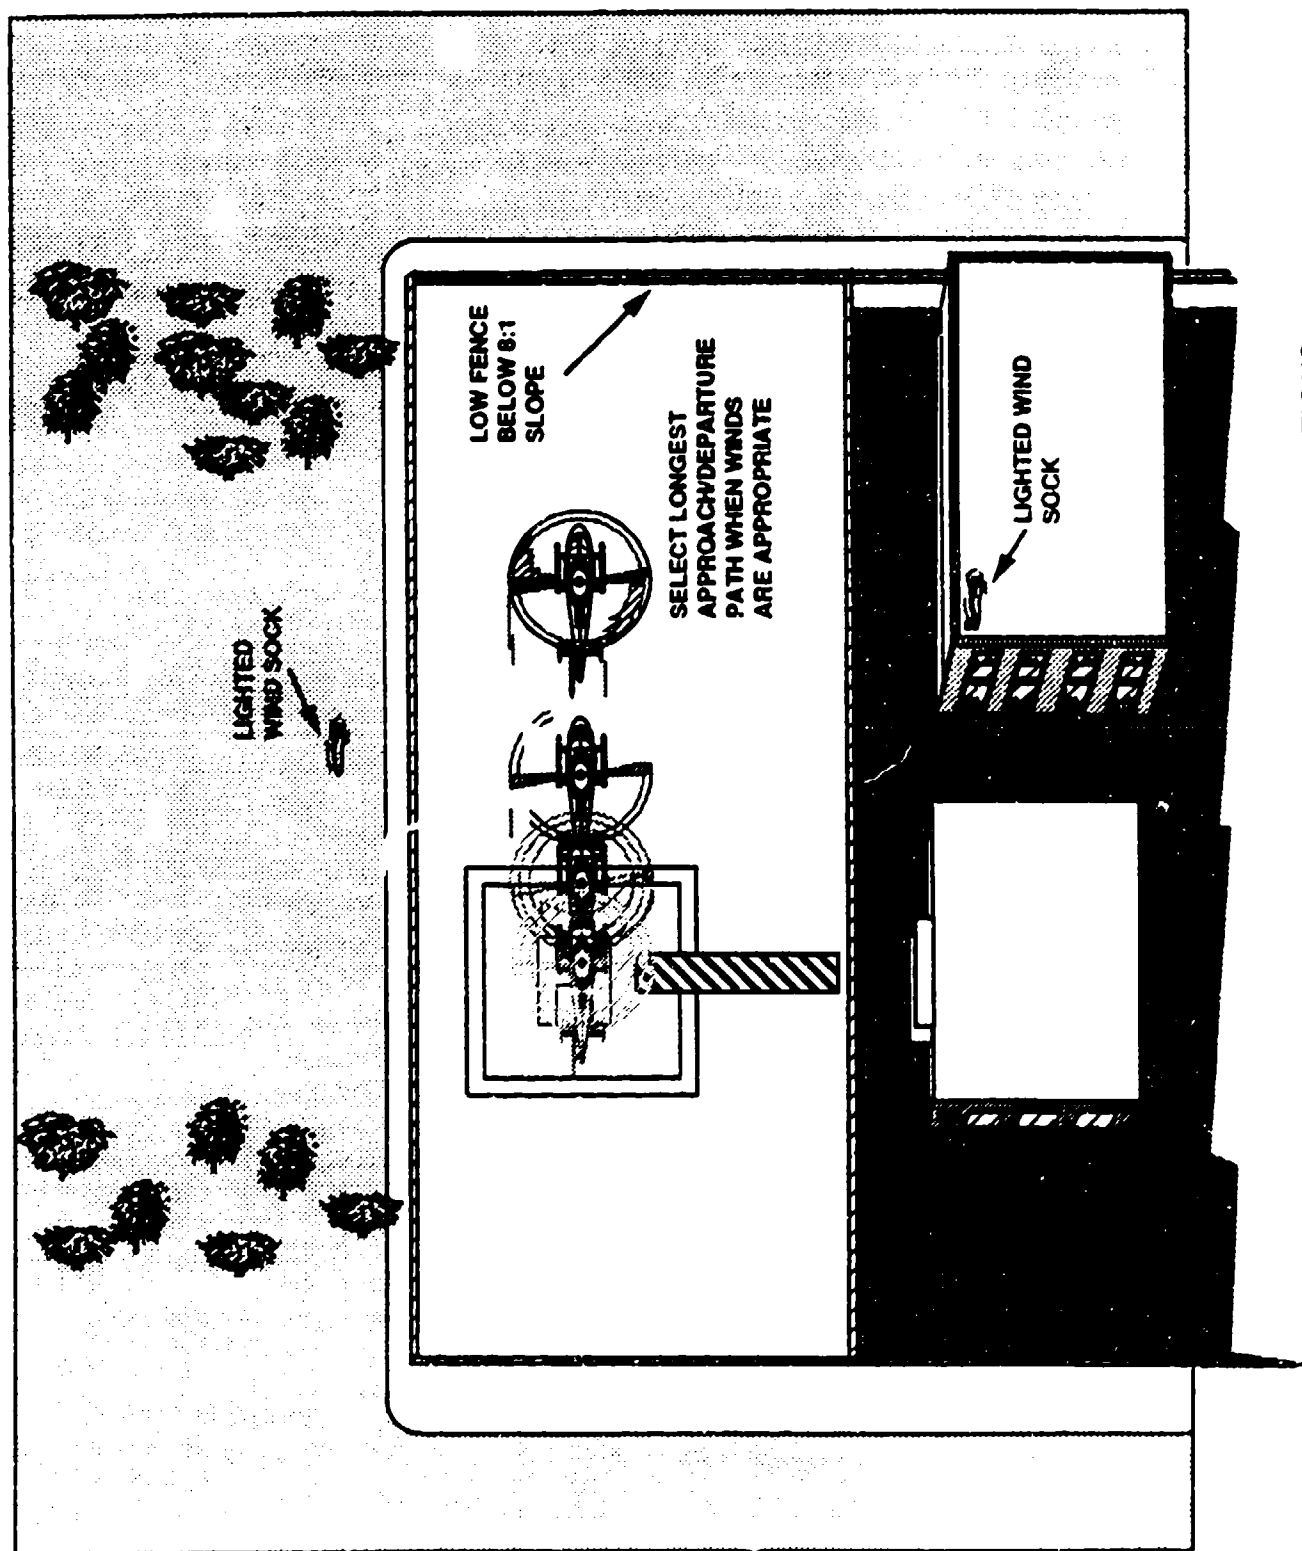
**FIGURE 23 IMPROVED HELIPORT DESIGN AND OPERATIONS**

public may become obstacles during an engine failure or a mishap during approach or departure. The desirable size and the practicality of providing rejected takeoff groundspace are controversial issues. Data from related studies including the helicopter performance (reference 4) and the helicopter rejected takeoff studies (reference 5) may be consulted for guidance. Figure 23 depicts the heliport with design improvements that enhance safety.

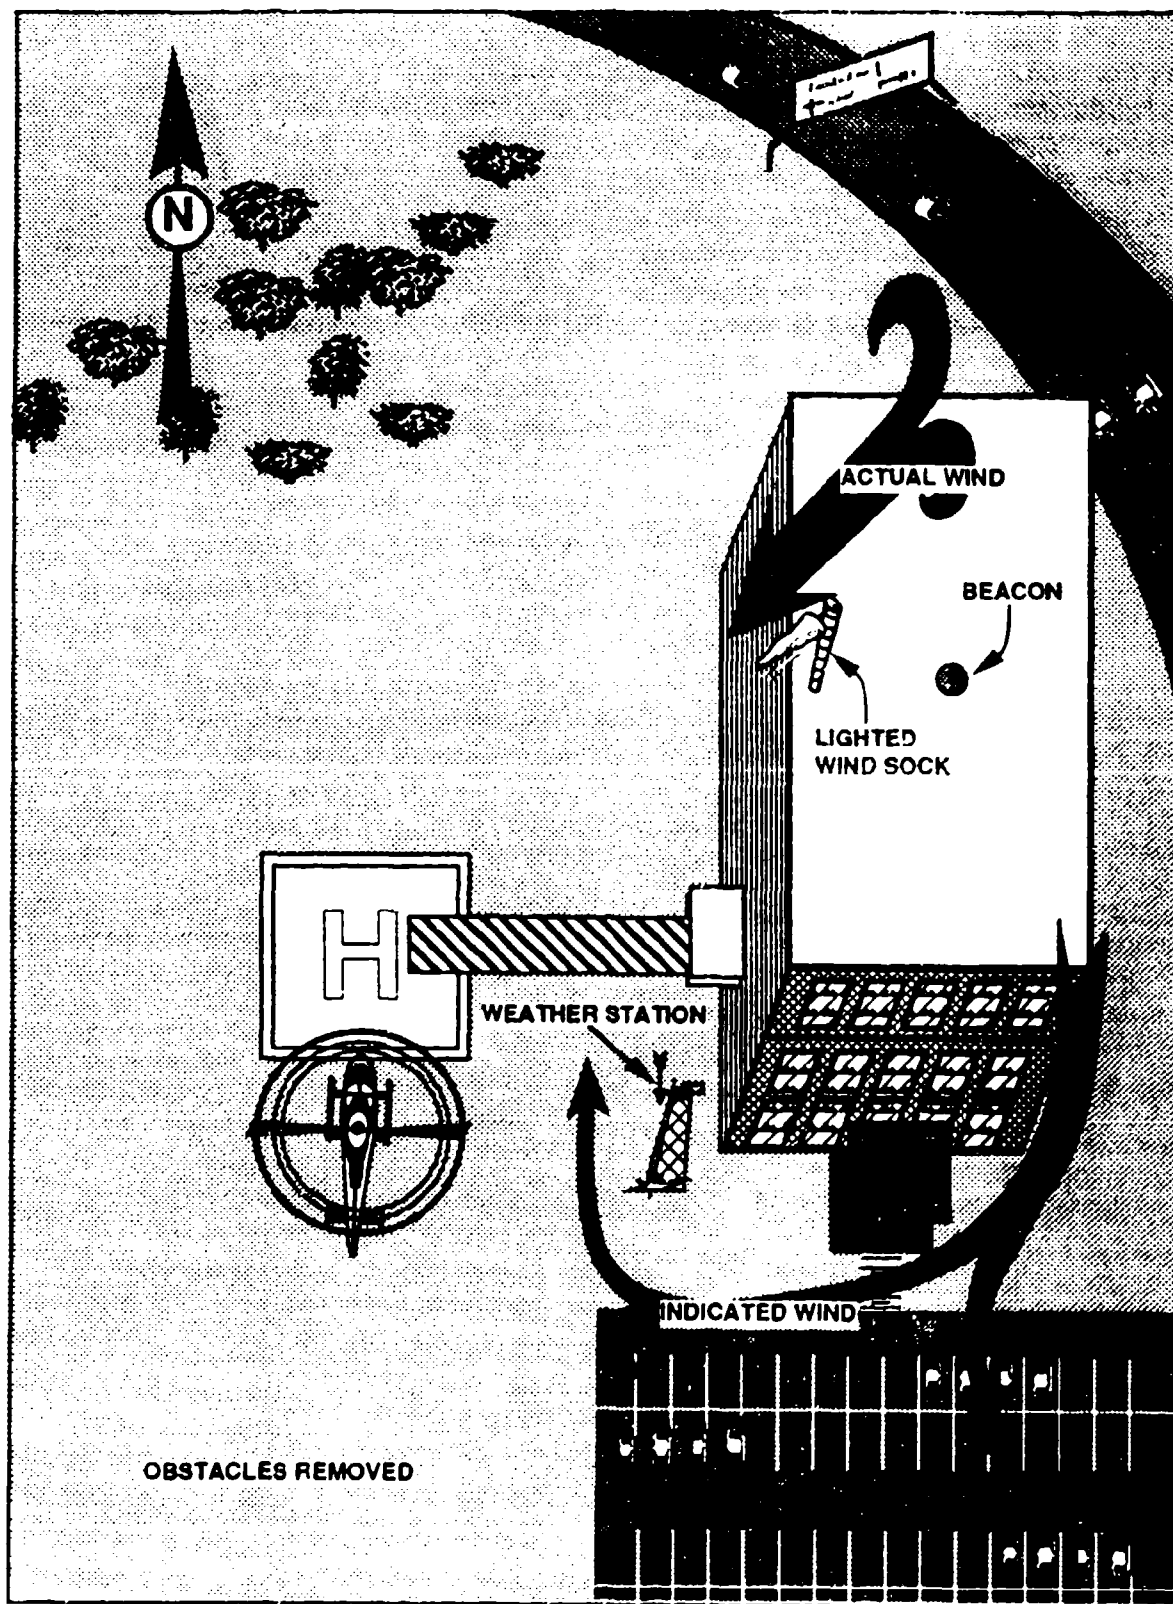
FIGURE 25 IMPROVED HELIPORT DESIGN - ADEQUATE WIND INDICATORS

Automated Weather Station - Automated weather stations offer voice broadcast of weather conditions that will be of great benefit to pilots. However, automated weather stations may not satisfy operational needs at all facilities for several reasons. The first consideration is that the visual cues that are available by using wind socks are not available with automated weather stations. Other concerns include the fact that not all automated stations have voice broadcasts, and even when they are offered, some aircraft may lack the capability to receive them. Since wind socks do provide visual cues of both wind speed and direction, heliport operators should use wind socks even when automated weather stations are in use at their facility. Figure 25 depicts the heliport with design improvements that enhance safety.

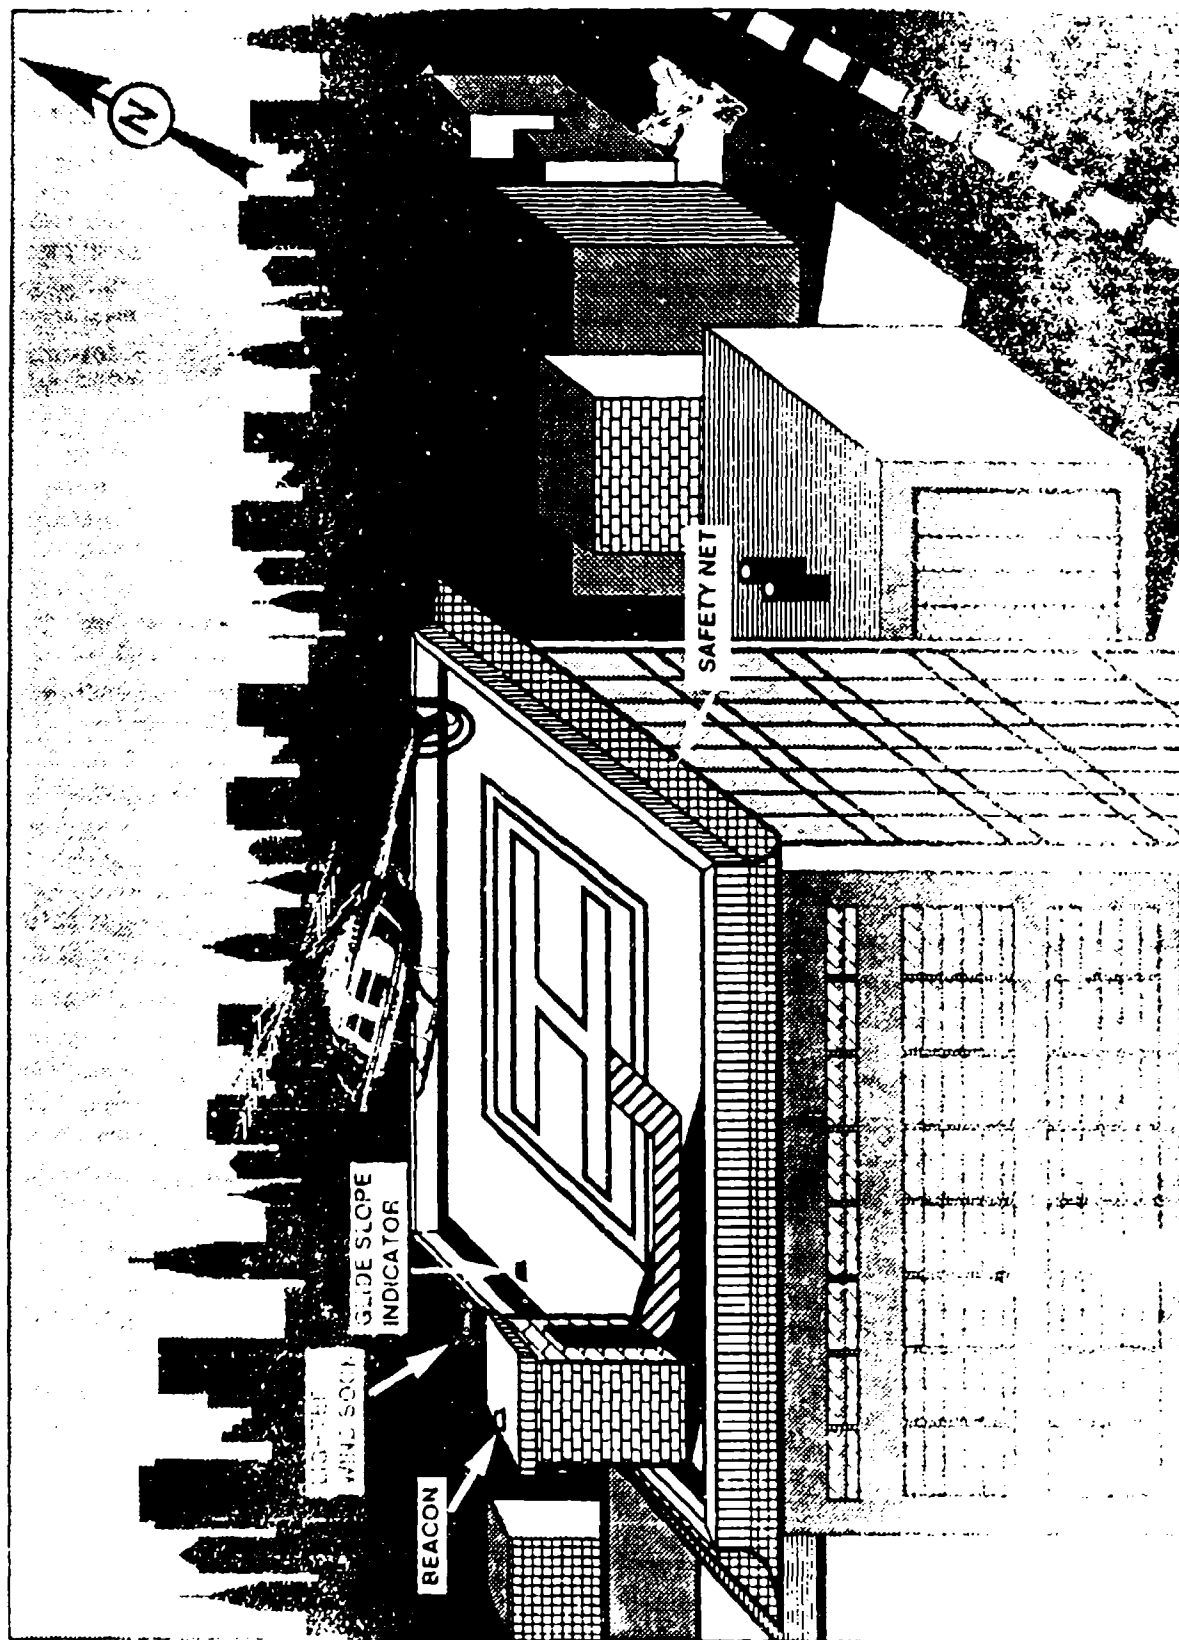
FIGURE 27 IMPROVED HELIPORT DESIGN - VISUAL GUIDANCE AIDS

Approach/Departure Path Selection - Approach and departure paths at heliports are established to consider a variety of conditions, such as prevailing wind, spatial orientation, proximity of buildings/obstacles around the landing area, noise, objects, and the population underlying the paths. Also, heliports may be marked or lighted to indicate the general direction for landing. In circumstances such as the one presented here, choosing an alternate approach path might be preferable. Figure 27 depicts the heliport with design improvements that enhance safety.

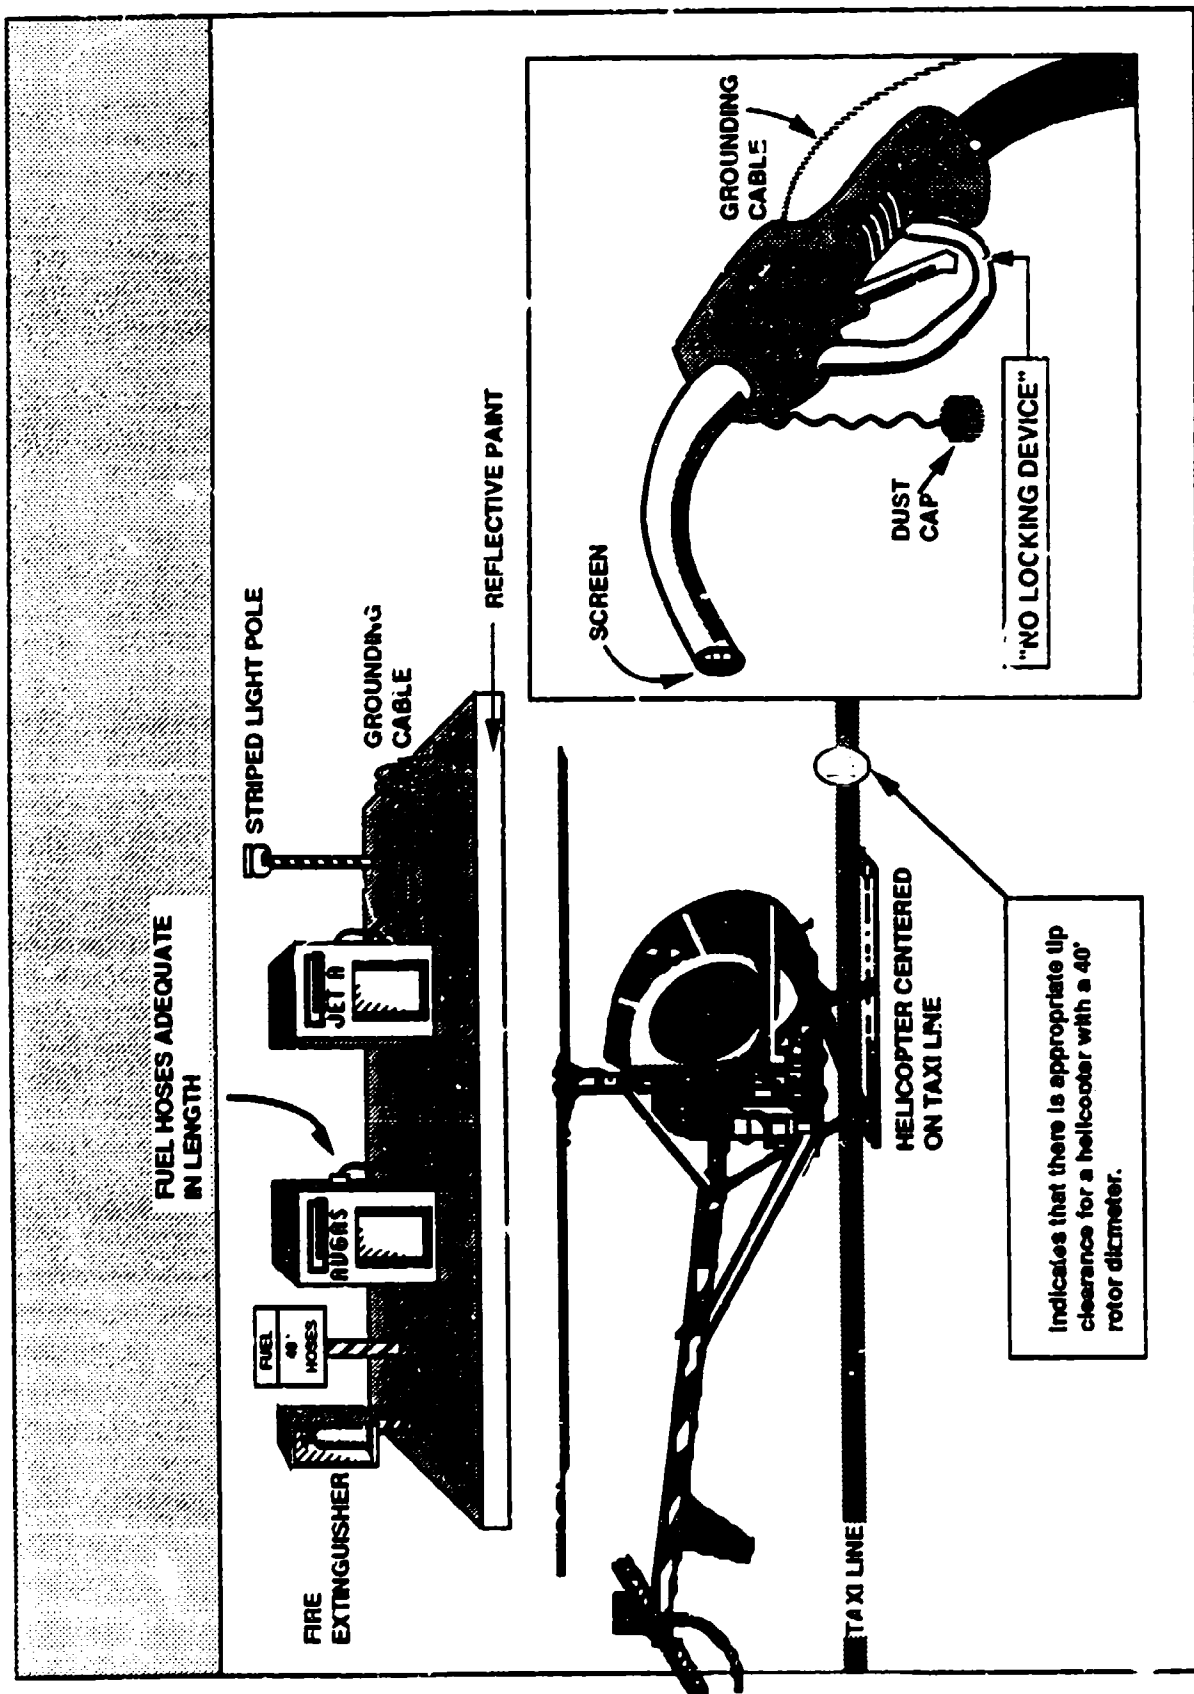
FIGURE 29 IMPROVED HELIPORT DESIGN - REFUELING FACILITY

Facility/Operator Responsibility - Ensuring proper refueling procedures is the responsibility of the facility operator. Fuel nozzles should not contain features that would allow them to automatically dispense fuel. Also, it should be stressed to employees that the nozzle should never be rigged to automatically dispense fuel, such as using a piece of wood to hold open the release lever. See insert on figure 29 for safety enhanced fuel nozzle.

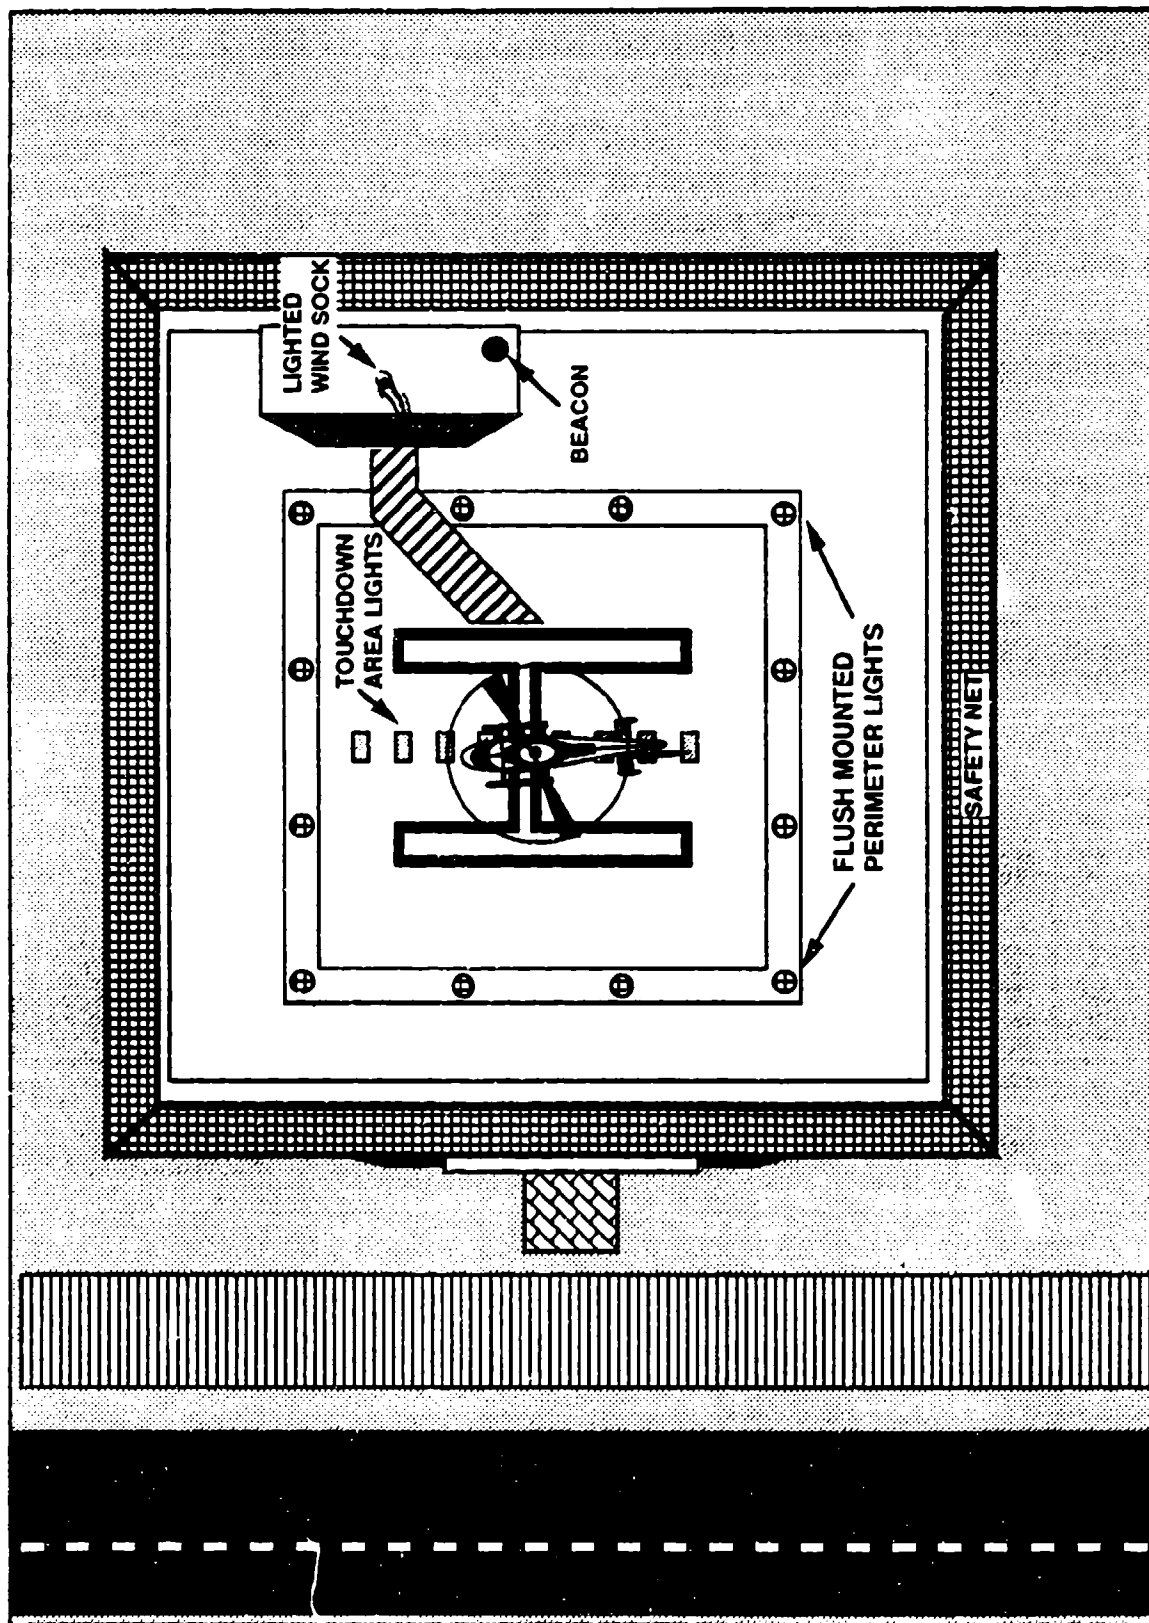
FIGURE 31 IMPROVED HELIPORT DESIGN - HELIPORT LIGHTING EQUIPMENT

operators make efforts to publicize specific information regarding lighting type, location, and height above ground.
